Breathe

Survival and the United States' Most Advanced Fighter Jet

Senior Management ViTS Meeting

March 2013

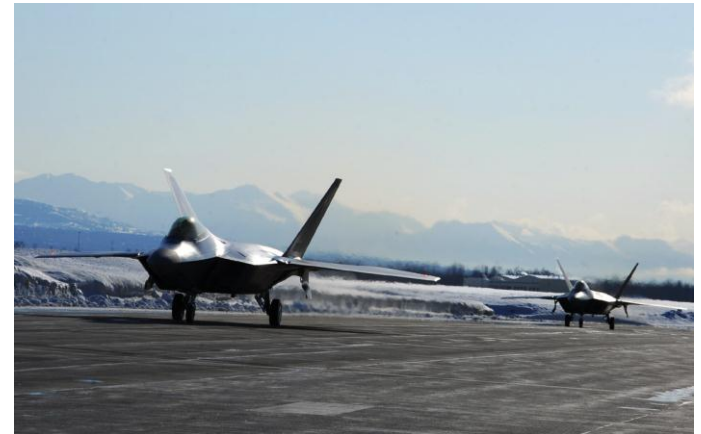
Figure 1.

- The F-22, introduced into United States Air Force (USAF) in December of 2005, is an air-to-air/air-to-ground, fifth-generation, single seat, twin-engine, supermaneuverable, superiority fighter utilizing state-of-the-art avionics, stealth, and supersonic cruise technology (Figure 1.).
- The mishap aircraft (MA) was properly inspected and maintained and had no history of reoccurring maintenance issues.

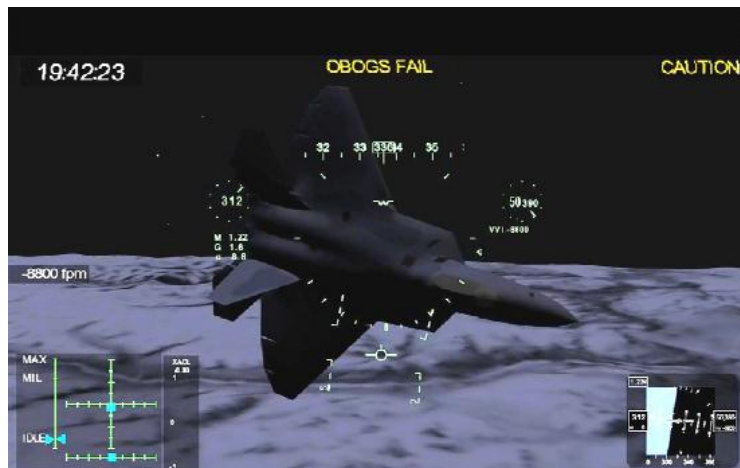
- At 7:39:57 p.m., the flight leader (FL) seeing the MP ahead of formation, directed the MP to return to a trail formation.
- The MP acknowledged in his last radio transmission. He initiated a climbing turn to rejoin, crossed FL's projected flight path, and then began descent into formation from approx. 52,000 ft. mean sea level (MSL) (Figure 2.).

Figure 2. The MA performing a descending right hand turn to rejoin formation.

- The MP would have immediately felt suffocated and would have struggled to breathe. Actual cabin altitude in the F-22A cockpit is unknown.
- The MP set throttles to idle, initiating a descent procedure until 7:42:45 p.m. (Figure 2.). There had been no pressure to the MP's oxygen mask since 7:42:37 p.m. For the next 8 secs, the MP made no control inputs. Passing through 19,000 ft. MSL, cabin pressure rose above nominal as the MA descended rapidly.

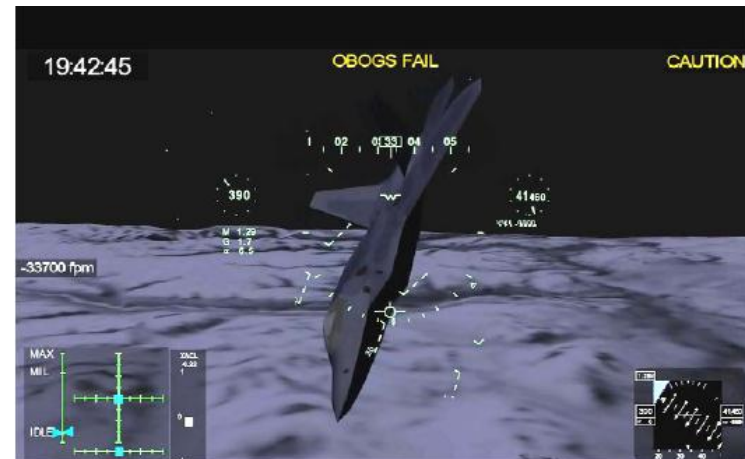
- At 7:42:53, the MP made a combination of stick and pedal inputs, initiating a 240-degree descending right roll at greater than 45 degrees per sec, rolling the MA inverted and plummeting down at a rate of -57,800 fpm (Figure 3.). There were no stick inputs and only very minor pedal inputs for the next 15 secs.

Figure 3. The MA position after MP stopped control inputs (no pressure to mask).

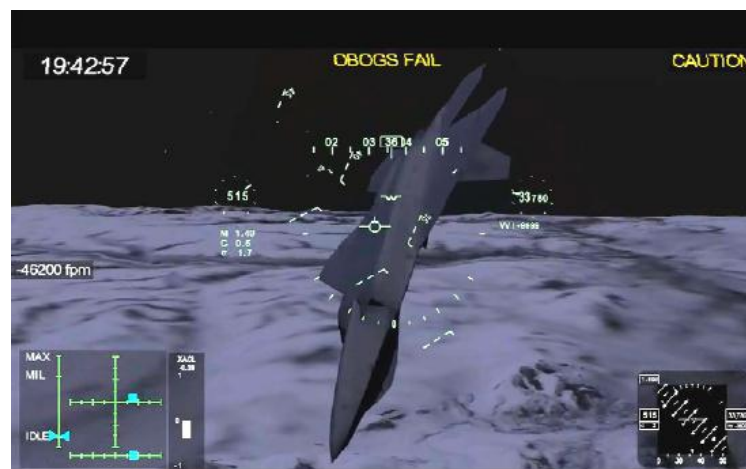
- At 7:43:24 p.m., the pilot pulled up, attempting a 7.4-g dive recovery at 5,470 ft. MSL. The pullout was initiated far too late to recover and the MA impacted the ground 3 secs later at a rate of -57,900 fpm, killing the MP.

Figure 4. The MA inverted and plummeting with no control input from MP (no pressure to mask).

The MP entered a 240-degree roll through inverted, and the nose down pitch attitude of the MA increased. Although a dive recovery was initiated, the MA impacted the ground, killing the MP.

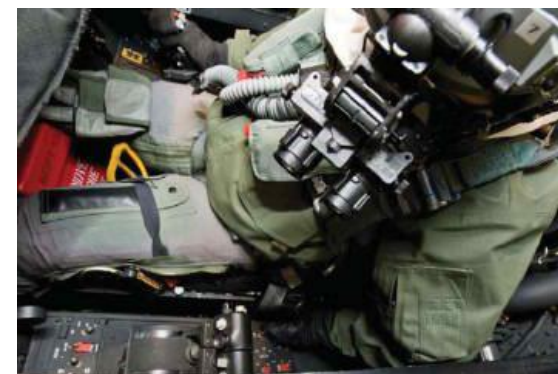
Figure 5.

- A CAT III gear and NVG cockpit maneuverability assessment revealed reduced mobility (Figure 5.). NVGs narrowed line of sight and interfered with visual scanning, requiring wearers to shift their torso while bracing against the cockpit to perform a scan. CAT III gear limited tactile sensation.
- Testers able to activate the small EOS pull-ring in CAT III gear and NVGs stated the 40lb-pull activation would be difficult and it was possible to drop the ring between the seat frame and cushion.

The Pentagon Inspector General investigating the Air Force investigation also deemed human error causal to the mishap. Civil legal action against the manufacturer resulted in changes to the design and location of the EOS activation mechanism.
